# Surface Cleanliness and Virus Presence on Cruise Ship Staff Premises

- The aim of the whole project was to investigate chemical, microbiological and particulate exposures in the cruise ship environment, as well as ways to reduce exposure to pollutants through optimal cleaning practices and ventilation techniques.
- The aim of the sub-study was to investigate the surface cleanliness of a cruise ship and the presence of viruses on surfaces

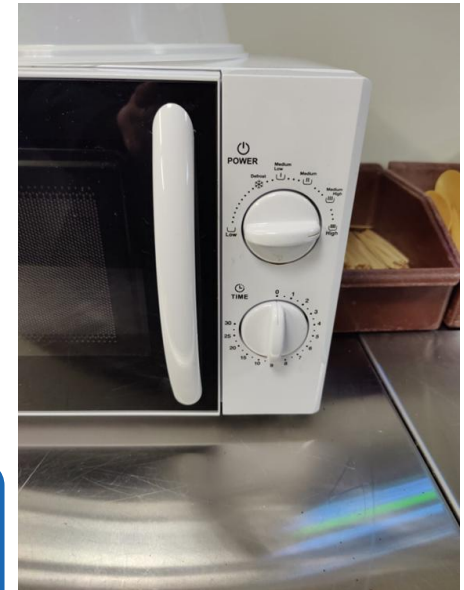
- The ATP measurement results were quite poor, which suggests that the surfaces were not as clean as required
- 5 pcs under 50 RLU, There were 12 results over 50–100 RLU,
- 75% of the results were bad.
- The worst value was 6038 RLU

Poor results may be partly due to biofilm broken by sampling or just too worn surfaces and the need for more effective cleaning
